6.12.5 The Four Cases

6.12.6 Characterization of the Thermal Profiles

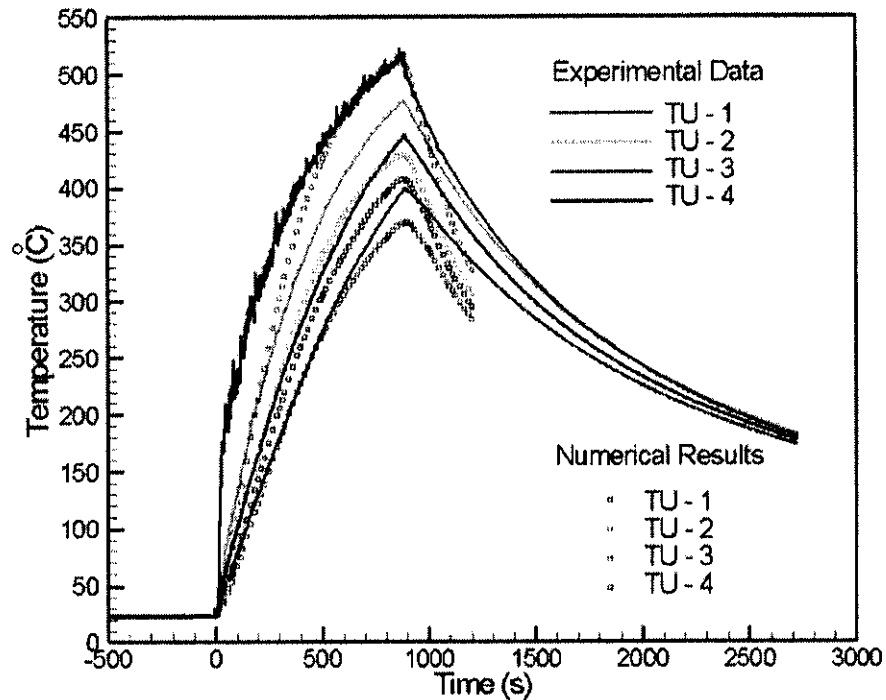
Figure 6–44 compares the measured and predicted temperatures on the steel surface of the top chord of a bare truss. Figure 6–45 is the analogous plot of the measured and predicted temperatures on the steel surface of the top chord of a truss insulated with 3/4 in. of BLAZE-SHIELD DC/F. Similar curves were generated for each of the steel pieces, bare and insulated.

Figure 6-44. Comparison of numerical simulations with measurements for the steel surface temperature at four locations on the top chord of a bare truss.

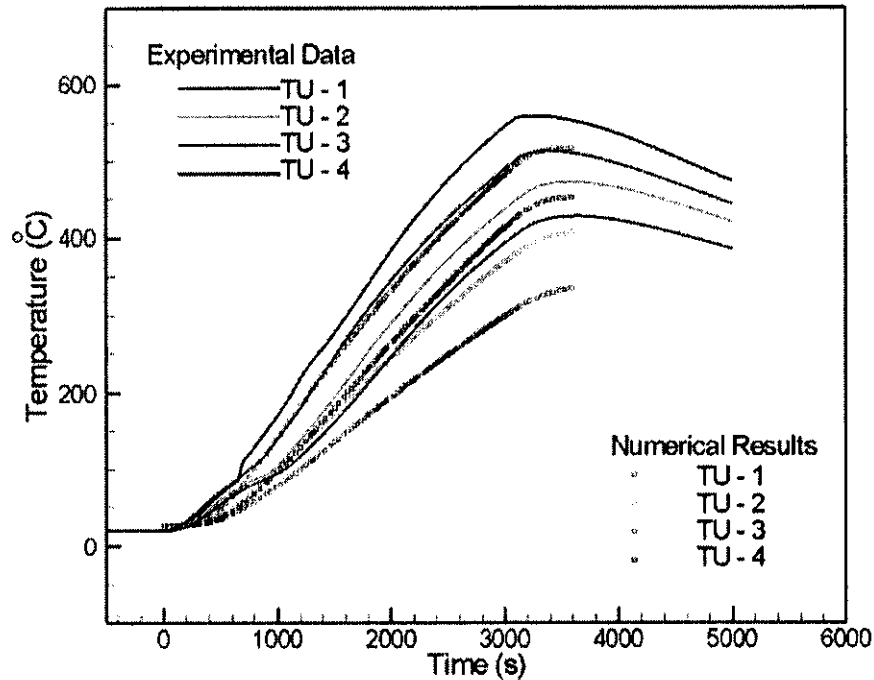
Figure 6-45. Comparison of numerical simulations with measurements for the temperature of the steel surface at four locations on the top chord of an insulated truss.

Examination of the graphs for the insulated steel pieces indicated the following:

- FSI captured the shape of the temperature rise at the steel surfaces and the significant decrease in the rate of temperature rise when the SFRM was present.
- The times to the peak temperature (or a near-plateau) were predicted to within about a minute in all cases.
- There was no consistent pattern of overprediction or underprediction of the surface temperatures.
- On the average, the numerical predictions of the steel surface temperature were within 7 percent of the experimental measurements for bare steel elements and within 17 percent for the insulated steel elements. The former was within the combined uncertainty in the temperature measurements and the heat release rate in the fire model. The increase in the latter was attributed to model sensitivity to the SFRM coating thickness and thermal conductivity.

An additional, important outcome of the experiments was the demonstration of the insulating effect of even 3/4 in. of SFRM. Trusses, made of relatively thin steel, were far more susceptible to heating than the perimeter and core columns. As shown in Figure 2-10, in 15 min, a bare truss reached a temperature at which significant loss of strength was imminent. An identical, but insulated truss had not reached that temperature in 50 min.

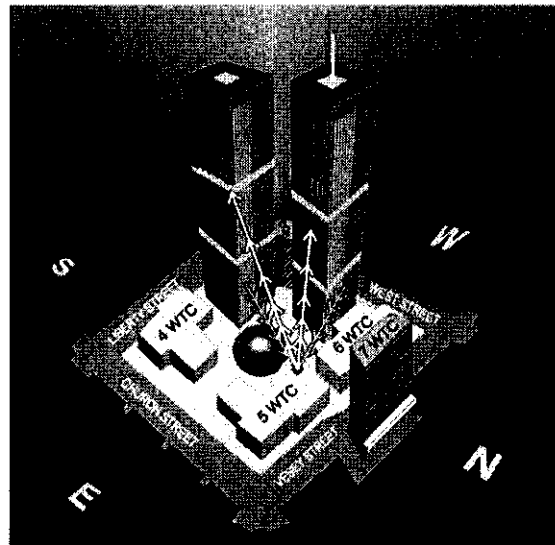
- Established a PAPD Command Center inside of WTC 5.
- Installed Fire Command Desks in the lobbies of WTC 1 and WTC 2.
- Installed in WTC 5 a radio repeater that operated on the FDNY city-wide high-rise frequency. (The radio repeater's function was to receive FDNY radio communication on a specified radio frequency, amplify the signal power, and retransmit the radio communications on another specified radio frequency that the FDNY radios could receive. This could enhance communications in buildings made of steel and reinforced concrete that pose challenges to radio-frequency communication.) The antenna was located on the top of WTC 5 and was directed at WTC 1 and WTC 2 (Figure 7-5). On September 11, 2001, the controls for operating the repeater were located at the Fire Command Desks in the tower lobbies.

Figure 7-5. Location of the radio repeater.

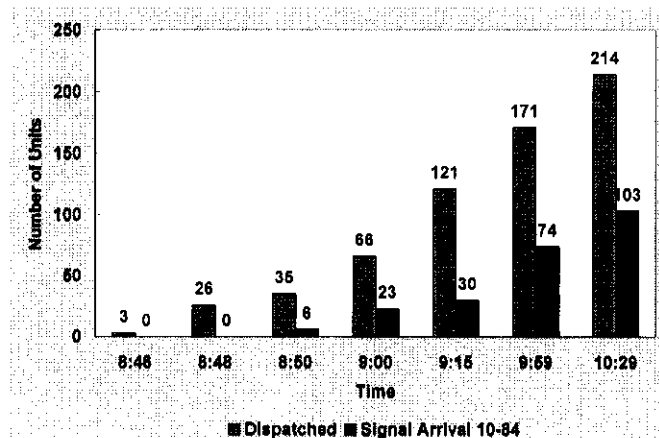
The emergency response to the attack was immediate. Within 3 min of the aircraft impact on WTC 1, PAPD was providing information on the attack to the police desk, FDNY had dispatched 26 units to the scene, and NYPD had called a department mobilization that included dispatching aviation units to the WTC for visual assessment. Within 10 min, PAPD had called a chemical mobilization; NYPD had dispatched five Emergency Service Unit (ESU) teams and had two aviation units at the scene providing observations. Within 30 min, 121 FDNY units had been dispatched to the scene and 30 units had signaled their arrival at the scene by pushing the “10-84” button on the vehicle’s communications console (Figure 7-6).

Figure 7-6. Timing of FDNY unit arrivals.

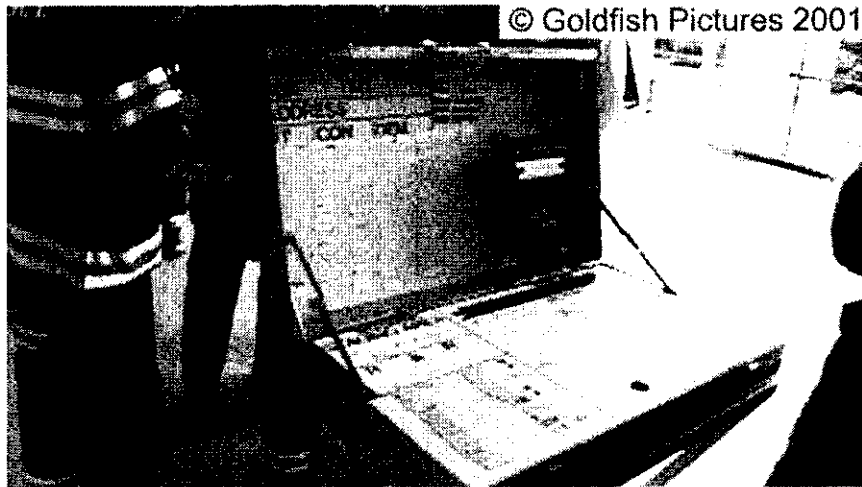
Thus, keeping track of what all these people were doing, where there were located, where they were going, and what they would do when they got there was a task without precedent. The principal tools for this were three 18 in. x 28 in. magnetic boards known as Fire Command Boards (Figure 7–7). They were located in the lobbies of WTC 1 and WTC 2 and at the Incident command Post on West Street. On each Board, magnetic identifiers of different colors identified engines, ladder and tower ladders, battalions, special units, and sectors. Unit numbers were written on the identifiers with marking pens. These Boards became overwhelmed after about 30 min due to the large number of people and units arriving at the scene. Some emergency personnel that arrived at the site did not report to the Command Posts or were not logged in on the Command Board. A formal analysis of arrivals and missions of the various units was compromised by the loss of the Boards in the collapse of the towers; there were no backup records.

Figure 7–7. Fire Command Board located in the lobby of WTC 1.
